Study of the effect on manufacturing parameters on the fatigue behavior of aluminum engine mounting bracket

Hossein Khalajzadeh¹, Seyed Vahid Hosseini^{*1}, Alireza Shaterzadeh¹

¹Faculty of Mechanical Engineering, Shahrood University of Technology, Shahrood, Iran.

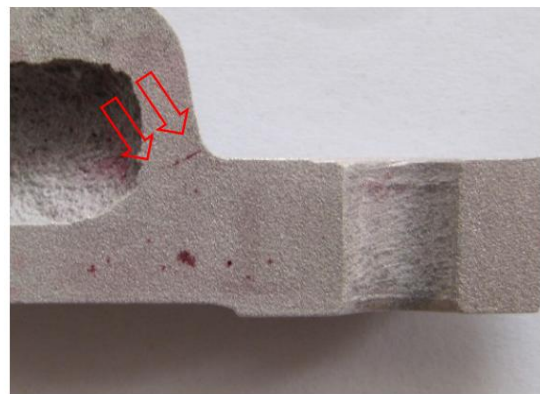
According to the ASTM E155 standard, after the machining of the part, the presence of holes up to 6 holes in the part with a maximum distance of 10 mm and a maximum depth of 2 mm cannot be the reason for failure in the part. As it is clear in Figure 6, it was observed that the crack did not occur in the connection area of the base to the wall due to the presence of a hole in this area.

Figure 6. Crack in the inner area of the connection of the base to the wall.
